HP 5065A Rubidium Vapor Frequency Standard
Ser. 0960A 00259

1.1 General condition and comments

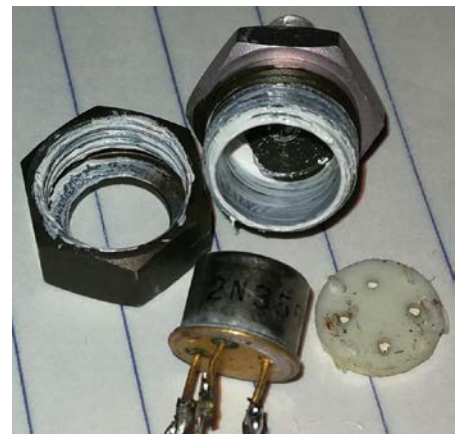
A12 has DB9 HR2 pin 5 (lamp heater) shorting to ground. All other 9-pin connector pins showed correct resistances and no grounds, but the cell heater was shorting to the ground shield of the CR1 harmonic diode and was then shorting to ground when that coax feed connects to J4 on A3. So both internal heaters need to be replaced, and preferably without altering the thermistors. Rather than fully extract the two internal aluminium tubes with their heaters, a somewhat simpler fix was to insert two new heater assemblies and retain the existing DB9 for thermistor and magnetic coil connection, but bring the heater wiring out separately and reconnect. Lamp heater wiring taken to DB9 plug and existing heater wires disconnected. See separate repair doc [[HP 05065-6001 lamp heater repair.pdf](#)]

Cell heater wires exiting separately and taken to rear of 6024 pcb connector.

The main 2N3553 Q2 had been previously replaced/repared. On inspection the 2N3553 emitter tab removed and smoothed, and insulator pad added between 1101A and top cover, and heatsink added to stud, to ensure no electrical contact. 1k33 resistor replaced on Corby's advice.

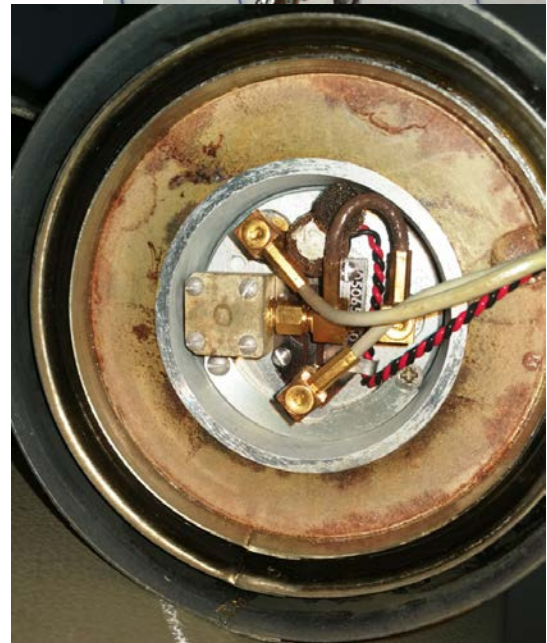
Lamp oven starts regulating after 35 mins, but has damped 8 sec period swings. Cell oven after 40 mins with 50 sec damped period. OCXO starts to regulate after about 50 mins. The hunting behaviour of the lamp and cell temp controllers was a result of the heater element repair short-cut used, where the heater coil was not directly over the thermistor.

Lamp oven meter swings sometimes extended to 50 on meter and tripped the logic to stop continuous operation. The top and bottom covers were not fitted, so unsure how much they may affect this meter swing. To alleviate logic tripping the A14 pcb was modified by adding 66uF BP e-cap between Q10 base and emitter to add .024x2x38= 1.8 sec TC to hi swing fault signal of Lamp oven (which turns off Q10 when it gets to within 1V of 22-30Vdc rail).
