Valve PA Amplifier System. \$70 eBay May 2011

## AUSTRALIAN SOUND AND TELEVISION CO. PTY LTD.

Combination amplifier, radio, record-player, with microphone input, and monitor speaker in free-standing steel cabinet. Used by primary school. Model/serial: 100 A 150. Contracted supplier. High quality chassis – punched for 2 additional preamp valves, and pots on front panel and top.

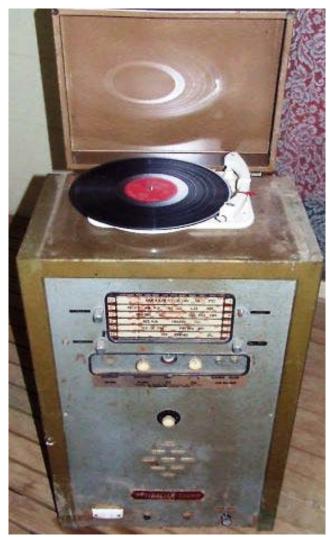
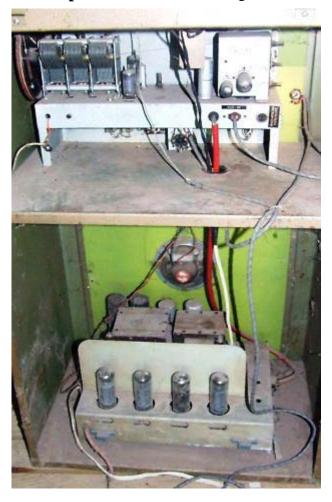
Issues - amp: electrolytics, switches, ac mains wiring.

- Megger test PT, choke and OT. Test turns ratios on OT.
- Restore with upgraded AC safety new mains cable, etc. Add NTC and MOV to primary side.
- Replace electrolytics use 470uF 450V cans. Use extra RC filter off doubler mid-point, for common screen HT (to reduce ripple).

- Replace SS diodes and remove tube diode OT protection. Add MOV-R OT primary protection. Add 6CA7 cathode fuses with parallel cold bias protection and idle current sense resistors.
