AWA G231 Audio Oscillator, Type 1A94771, S.N. 129 July 2011

10Hz to 30kHz, 40 & 600 ohm source impedance; Balanced or unbalanced output; -60dB to +20dB switching in 10dB steps, with output level pot; large dBm and voltage meter; 24V and 48VDC powering.

Repairs

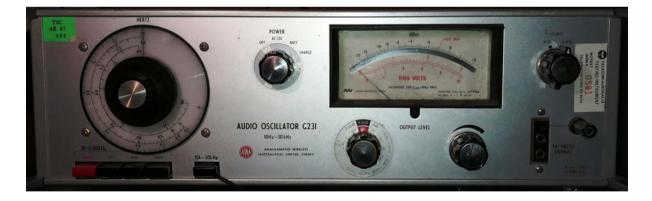
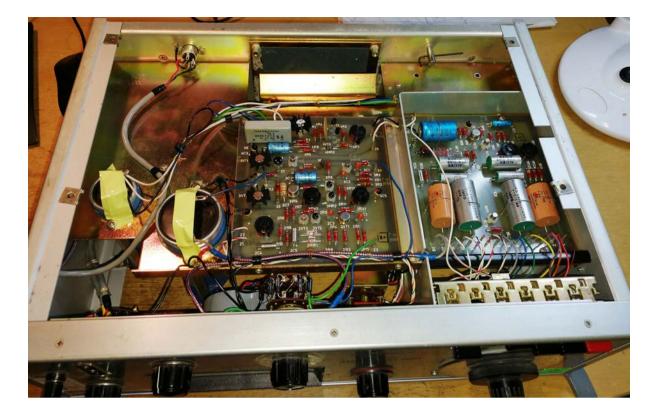
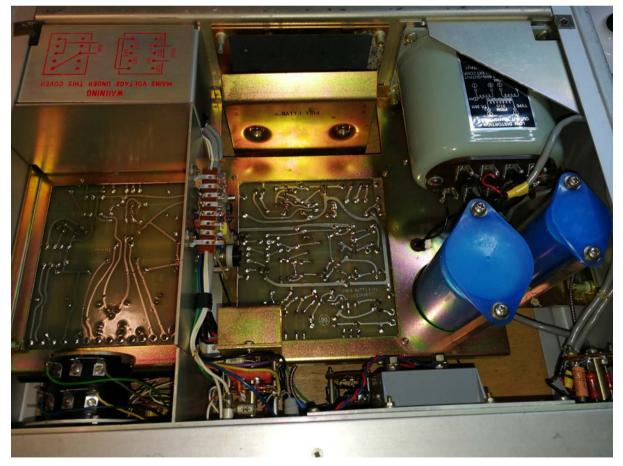
Initial condition:

From Telecom, Network Management Unit. Last tested 2001 Mains fuse was wrong size - should be 2AG. Mains power transformer failed. 18V power regulator failed 20 yr old NiCads

18V power regulator failed - all 3 transistors failed - replaced - now ok
2N4249 PNP; 60V; 100 hfe; 200mW; cbe
BC640 ECB - bar on top - pin view
2N4036 PNP; 65V; 1A; can cbe (c can)
2N3693 npn; 45V; to-106; 40 hfe at 10ma; cbe
bc639 npn; ecb - bar on top - pin view

Two battery strings removed (20 yr old NiCads). B-Y, G-R. 10x C size per string (1Ah).

Mains power transformer removed. Mains bulgin socket removed. Replaced by rubber grommet and external battery input lead. Not worth retrofitting a transformer and an IEC socket, as significant benefit from just using external 24Vdc VRLA (2x 12V monoblocks). AC shielded wiring to SWD disconnected and soldered together with FS1 and to gnd. Disconnected terminal 38 (C1 positive) to remove C1 charging, although MR2 does that function too.

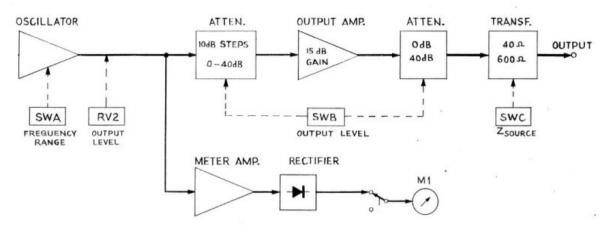
The block diagram of the equipment shows the oscillator feeding both a meter stage, and the main signal path including coupled attenuation and gain stages, and output transformer isolation. The oscillator stage generates a stable 1Vrms, and that is where an external oscillator can be easily inserted (and the oscillator can be turned off from the front panel switches).

Replacing the oscillator stage with a USB soundcard interface line output set for 1.0Vrms would allow the G231 to provide gain and attenuator steps, and metering, with transformer isolated 40 and 600 ohm output.

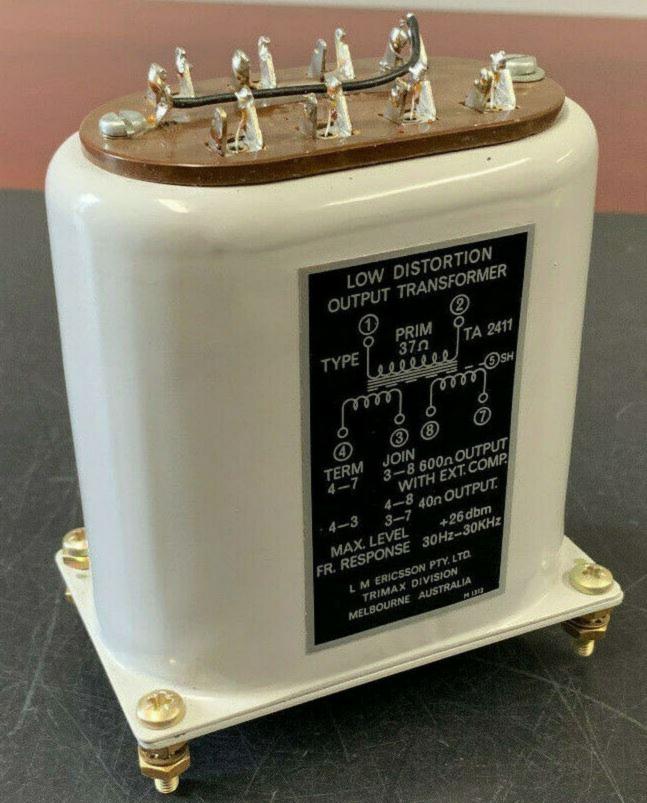
Not only does the soundcard provide a lower raw distortion oscillator, with THD now down at 0.01%, but software can null that down to 0.001% if needed, so not too shabby indeed for performance testing. And software can now allow this unit to be part of a bench setup performing many forms of noise and distortion testing including automated frequency sweeps, especially when there is a need for enhanced transformer signal isolation with low impedance drive capability, along with a signal level meter. About the only note is that the G231 hardware has a limited specified frequency range of 10Hz to 30kHz, with some expected fall-off beyond that range (which may be able to be calibrated out), given that modern soundcards can typically test out to 96kHz.
