1. Summary

NEC (Northeast Electronics Corp, USA) Impulse Counter & Noise Measuring Set, Model 58B, S.N. 147. HRSA May 2024.

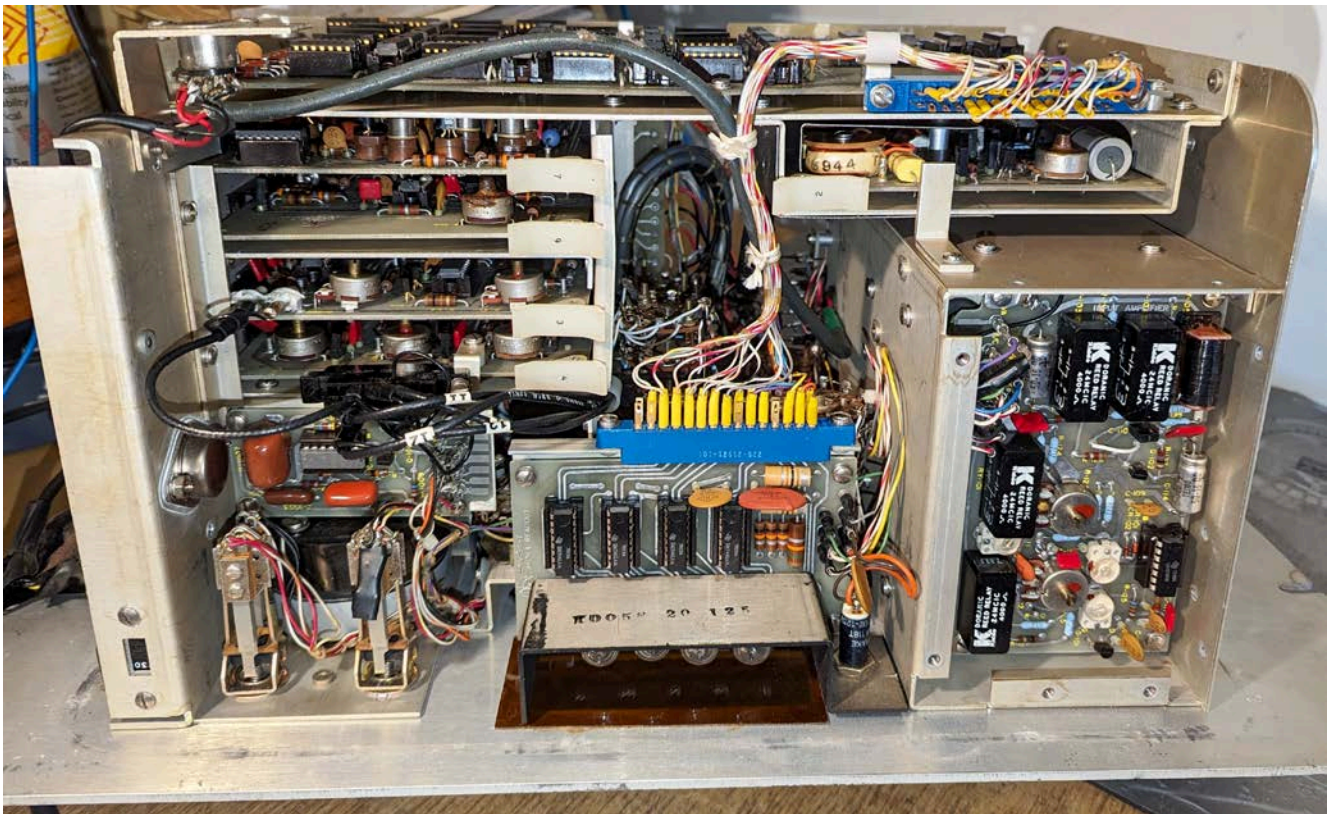
Rear hood removed showing shelved pcb assemblies. RHS input related circuitry and input amp/attenuation pcb assembly are totally enclosed in compartments. An extender pcb provided in unit to allow adjustment of pcb assemblies in shelves.

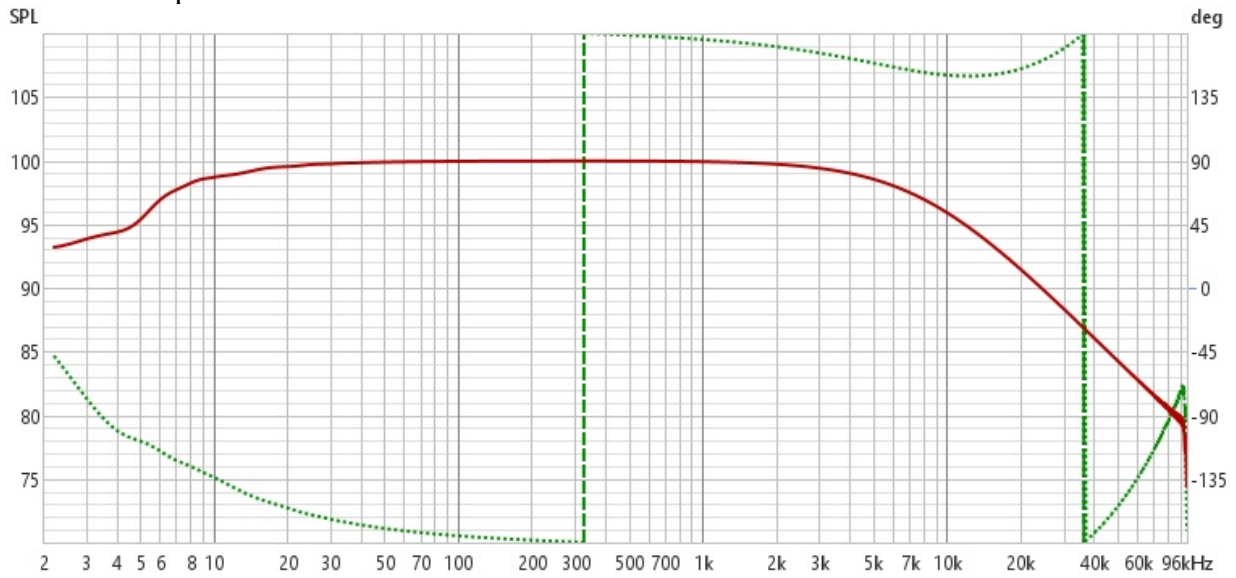
FLAT filter response inserted a nominal ~8kHz first-order HPF.

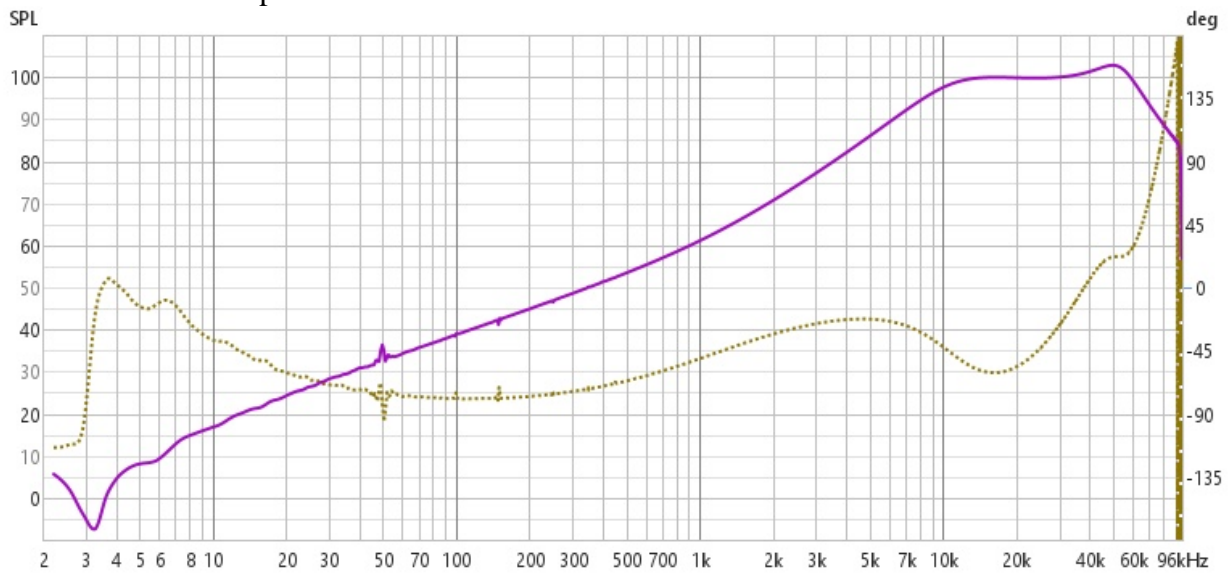
10.2-51KHZ filter response showed flat bandwidth.

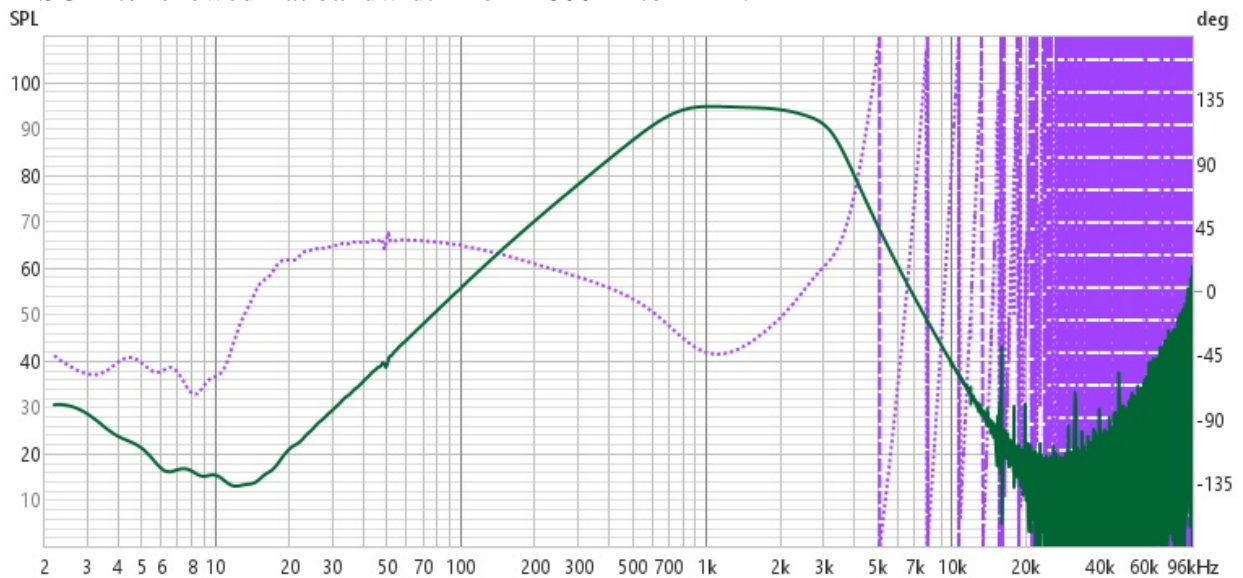
C-MSG filter showed flat bandwidth from ~800Hz to 2kHz.
