1. Summary

Gambrell Bros. & Co. Ltd. London   4x decade resistance box 1Ω to 9,999Ω.
S/N 722

2. Restoration

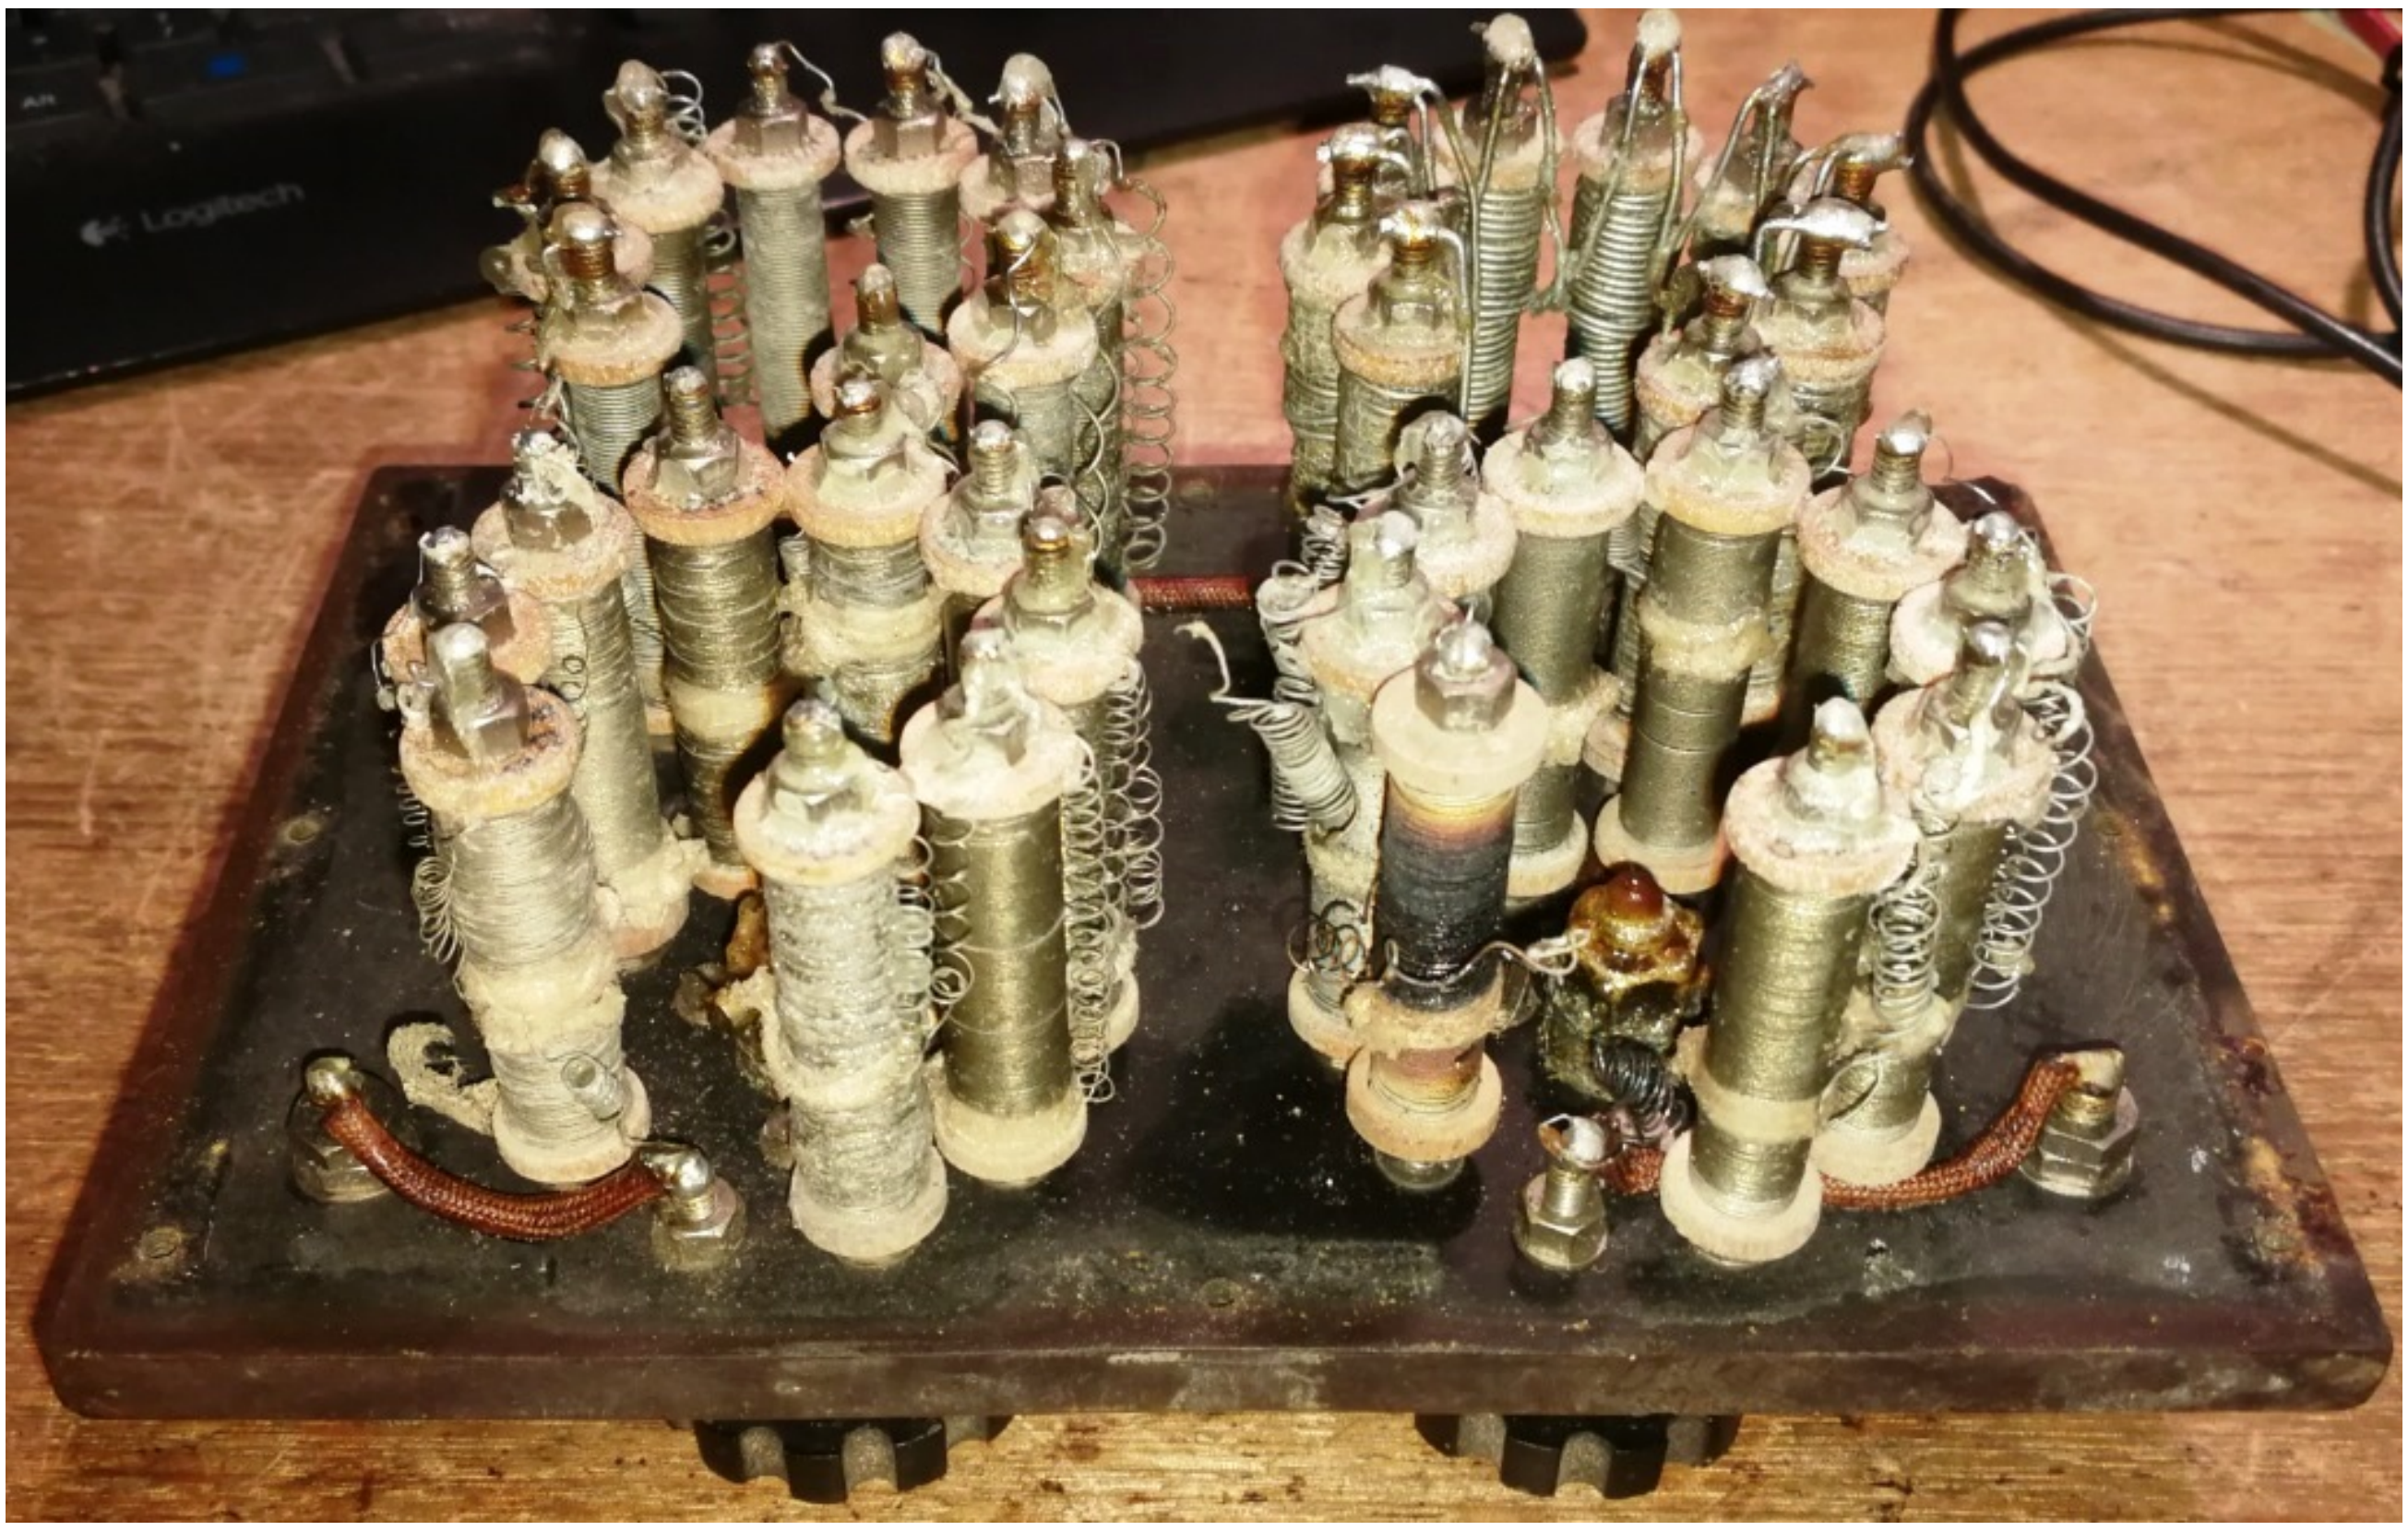
Poor external and internal condition. Missing cracked corner of top bakelite. Burnt 100Ω element. Poor resistance contacts on rotary switches. 3 resistor elements with slightly high levels (70Ω; 5kΩ; 9kΩ; and 1 with slightly low level (5Ω). 1 element with broken connection wire (1kΩ).

The burnt 100Ω element bobbin was removed and the retaining wire wrapping removed to allow the outer layer of burnt wire to be free, but with the next layer of wire held so as not to uncoil. The burnt layer wire had its carbonised insulation dusted off and the un-tensioned layer was then fixed in place with an archive pva glue. Insulation tape was wrapped around part of the length and the final turns were separated and moved down to be over the insulation tape until no turns were touching (slightly lowering the net resistance) or shorting (due to the bifilar wound configuration). The loose coil turns were fixed in place and the element re-mounted and reconnected.

The broken connection wire on one of the elements was repaired as an in-line soldered joint.

The 5k and 9k elements were similarly repaired – a weak/broken point was identified ~4Ω in to one end (underneath the cotton tie), and that point was extended out and re-terminated to about 3Ω of the broken extension (using a shoe-lace lug and solder). The loose ends were soldered to end posts for latter use if needed.

The resistor element mounting bolt contact pads had the top oxide layer sanded down using 1000 grit paper until rotary contact operation was generally ok (some caution is needed as contact resistance variation can occur). Each pad clearly shows three parallel wear tracks. Contact cleaner lubricant was then used.
