This article discusses protection topics related to a valve amplifier's output transformer.

Over-current and over-voltage stresses are common causes of output transformer failure, so these two topics are discussed in detail. The influences that can cause stress are described, along with common techniques for managing those stresses. Fuse and PTC selection for over-current is discussed. MOV selection for output transformer over-voltage protection is presented as a simple addition.

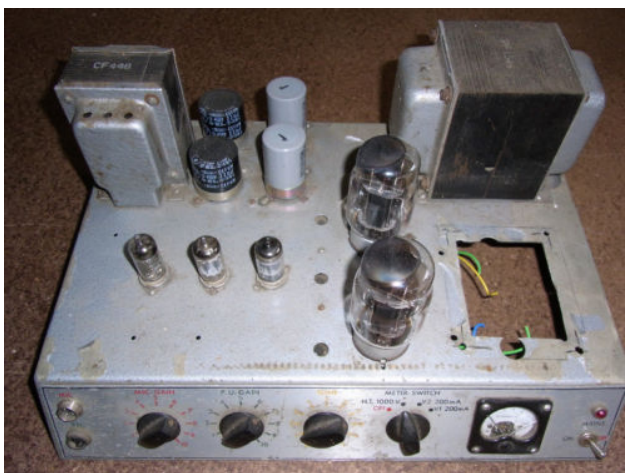
Figure 1. Amp purchased with no OT.

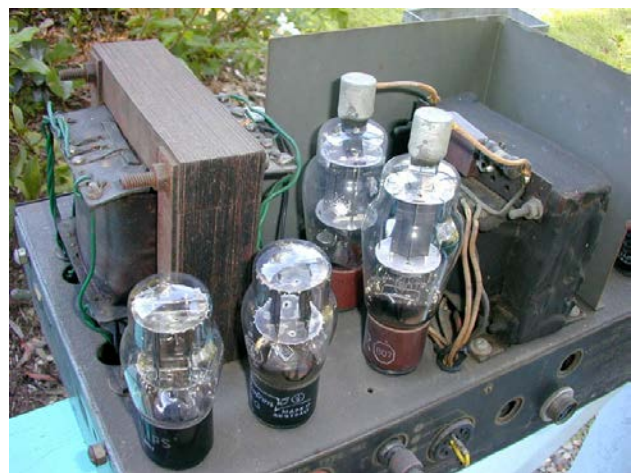
Like all parts, adequate cooling is required for the OT. Some amplifiers have a poor layout of transformers and valves, with parts sandwiched together in close proximity, and with limited ability for free air movement to allow removal of heat. Some old amplifiers that were intended for PA use, with output power only intermittently needed, were borderline examples. When restoring for modern day use as a guitar or bass amp, then be aware of the likelihood of the amp having a higher continuous output loading than originally intended, and be often cranked into over-drive.

OT sandwiched between output valves and barriers.

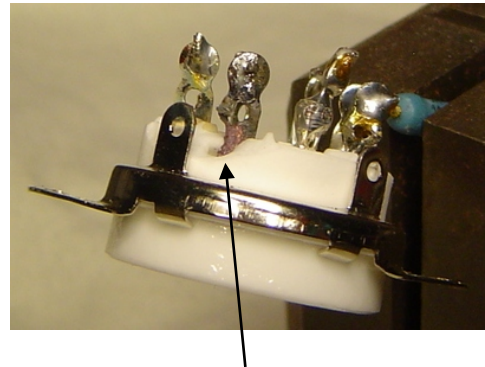
Faults can even occur during servicing – note pin in photo.

A meter probe accidentally shorted pin 3 of an output valve to a nearby grounded socket holder's earthing tab when the amp was on. The OT half-primary winding inductance ensured the arc continued, even when the probe was quickly removed, and the arc continued for a few seconds eating away at the pin 3 terminal and cracking the ceramic edge, until the only fuse in the amp (PT mains side) blew. The OT survived in this particular case!

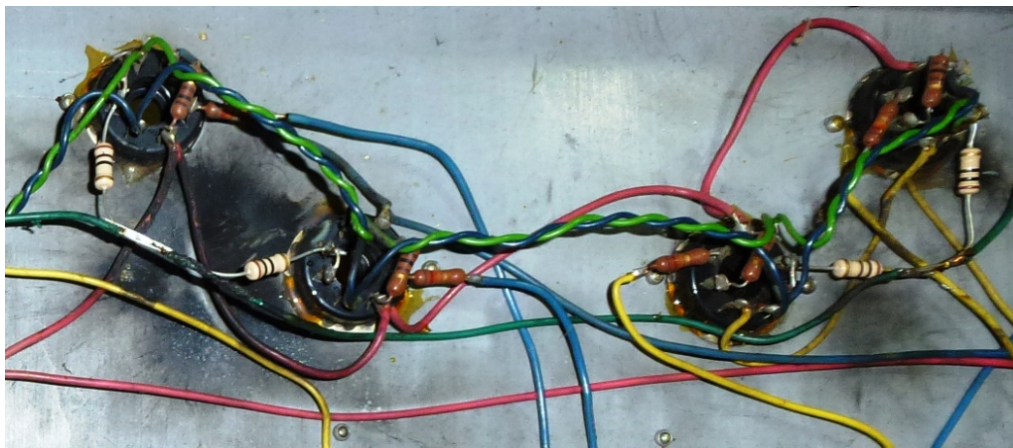
Figure 2. Poor man's fusing probably saved the OT in this repaired Phone amp.

For larger amplifiers, especially those that run parallel valves in the output stage, the addition of a fuse in each valve cathode 'leg' provides better protection as each cathode fuse rating can be made significantly lower than the secondary side PT power supply fuse rating. Even a low wattage current sense resistor used for idle current bias adjustment for each cathode could be used as a 'poor man's fuse' – however the resistor needs to have a wattage rating just suited to the overdrive conditions¹. Some hi-fi amps even capacitor bypass the fuse, or sense resistor and fuse, to minimise their influence on signal performance.

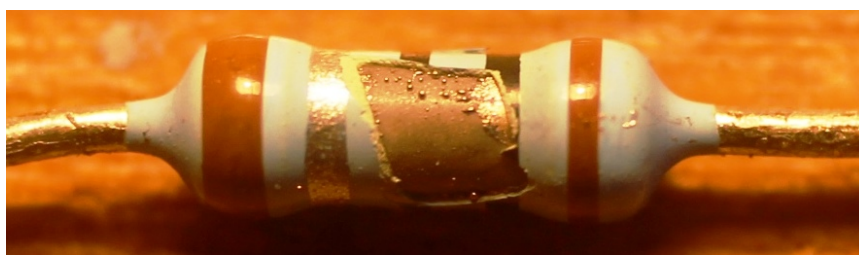
Figure 3. 10Ω metal film for cathode current sensing. "Popped" by a bad 6GW8.

¹ Overload testing on some 0.6W MF MRS25 1Ω and 10Ω resistors showed they could still 'function' even when subjected to 15x their dissipation rating (ie. 9W, or 3A for 1Ω, and 1A for 10Ω), with the acrid fumes being an indicator of a fault. Only some manufacturers make 1Ω MF resistors in 0.4W or 0.25W ratings, whereas 10Ω 0.25W is appropriate for cathode sensing to 160mA continuous (ie. class A, or 320mA with 50% duty-cycle).

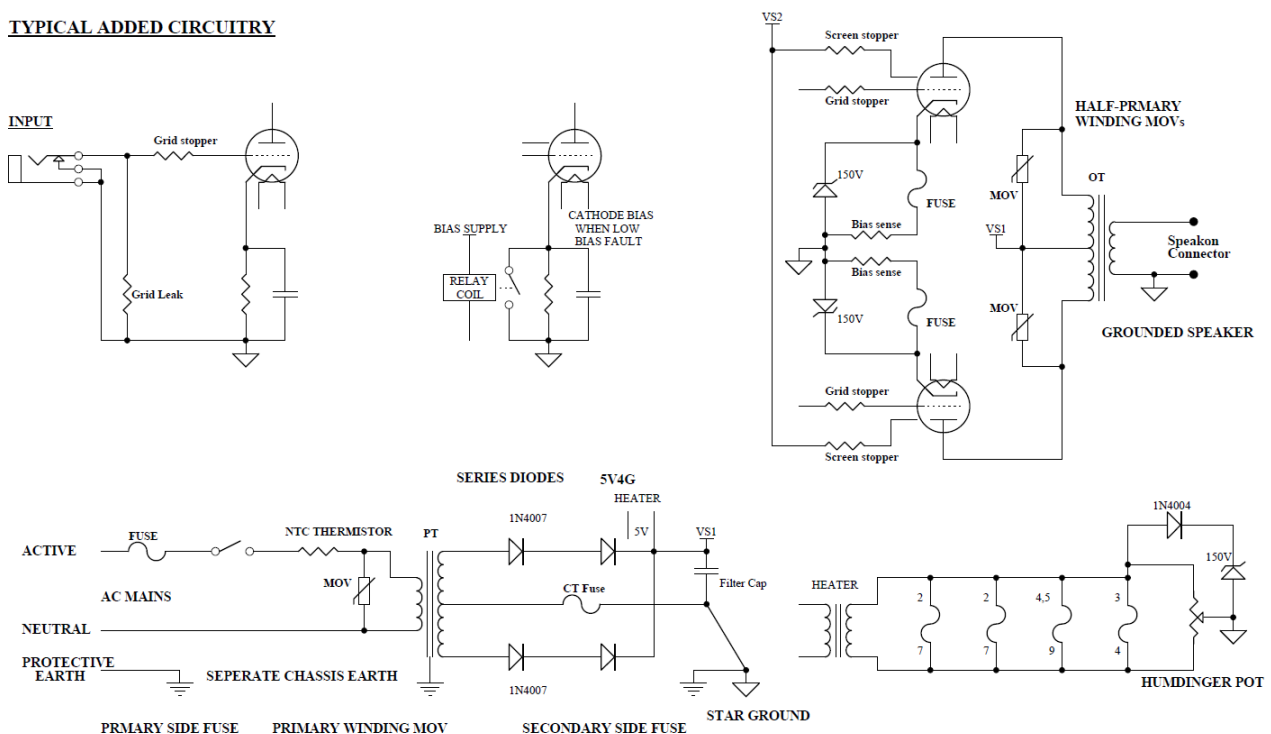
TYPICAL ADDED CIRCUITRY

Figure 4. Typically added circuitry for protection.

Of note is GEC's technique for bias loss, where a relay contact shorts out a protective cathode bias resistor during normal operation. If bias is lost then the relay contact opens, and the output stage operates with cathode bias. An alternative to an electromechanical relay is a modern optomom form B device - an LCB110 has $< 10\Omega$ contact resistance (DC only configuration) and only needs about 2mA of LED current.

Cathode biased output stages, and screen 'stopper' resistors can significantly suppress fault current levels for some types of over-current fault. Adding screen stoppers in an old amplifier that had none in place can be worthwhile to reduce OT over-current stress in UL stages, or triode connected pentode PP stages, as well as PT stress if the screen internally shorts. Typical parts used for protection in a fixed bias PP stage are shown in Figure 4 below.

Adding a silicon diode (one or more 1N4007 in series depending on the HT level – see '[Power supply issues for tube amps](#)') in series with each anode of a diode valve (as shown in Figure 4) can avoid shorting out the power transformer HT secondary winding if the valve diode starts to conduct continuously, or arcs between anode and cathode (eg. gassy tube). When using protection solid-state diodes, a valve diode fault could go unnoticed, unless it is observed as an increase in hum, or as a B+ level when B+ AC and DC voltage is next checked, in which case it should be fixed as soon as possible. Using an insulation resistance tester at 1kVdc is also a [practical maintenance action](#) to check for valve diode performance.

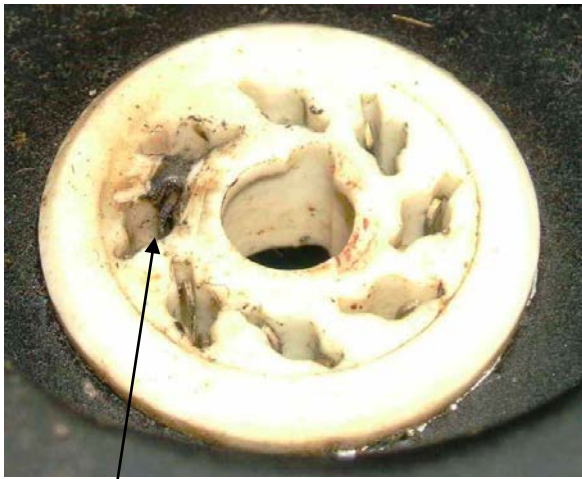
Arc-over from heater to anode [thanks Ian]

Figure 5. Some practical examples.

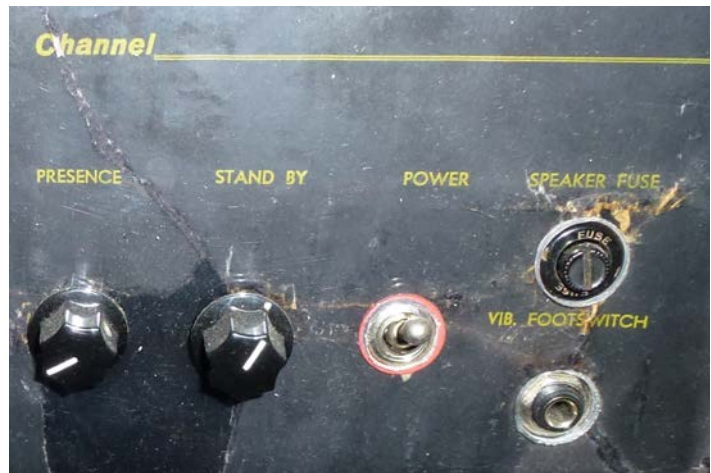
Speaker fusing is not common – with good reason!

For the example of an abruptly disconnected speaker lead, the inductive energy in the OT secondary winding could couple to a primary winding that has a valve conducting, and hence the energy has an escape path that would not likely cause a problem. If the primary winding valves were in cut-off (eg. due to crossover distortion) at the time of the fault then the inductive energy in the faulted winding has no other option than to couple to all OT windings and raise all available stray capacitances within the OT to a high voltage spike level. The inductive energy ($0.5 \times L \times I^2$) is transformed to a voltage rise V across stray capacitances in the OT windings ($0.5 \times C \times V^2$).

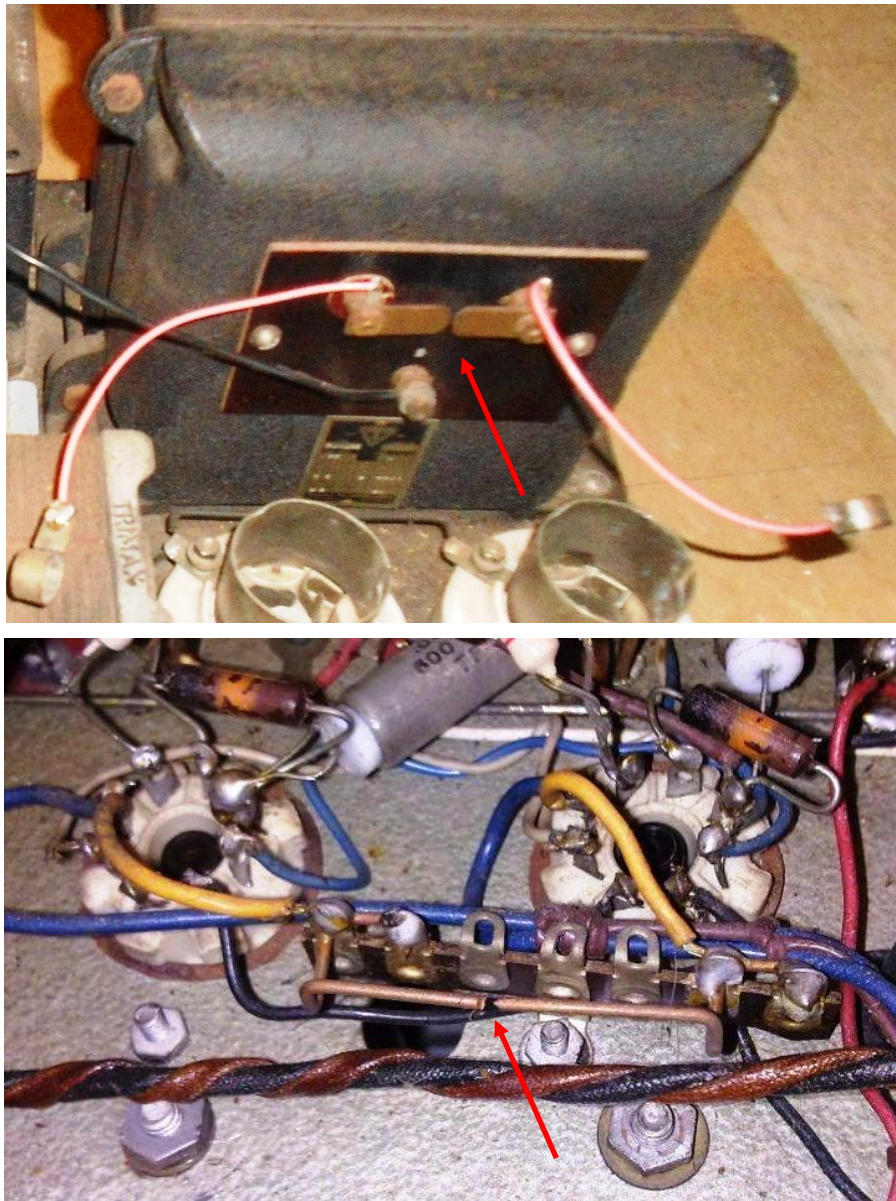
Figure 6. Examples of spark gap placed from plate-to-plate.

Over-voltage protection was sometimes included in amplifiers, especially Public Address (PA) amplifiers. Two examples of the 'spark gap' technique, shown in Figure 6, show the gap placed from plate to plate in a PP stage - although crude in form and not very accurate under varying humidity and dust conditions, it probably worked ok and was certainly appropriate for very high powered amplifiers [An approach to audio frequency amplifier design, GEC, 1957]. It may well have saved the OT shown in this thread ([video link now dead in thread](#)) when a newb foolishly checked if an old amp was still working.

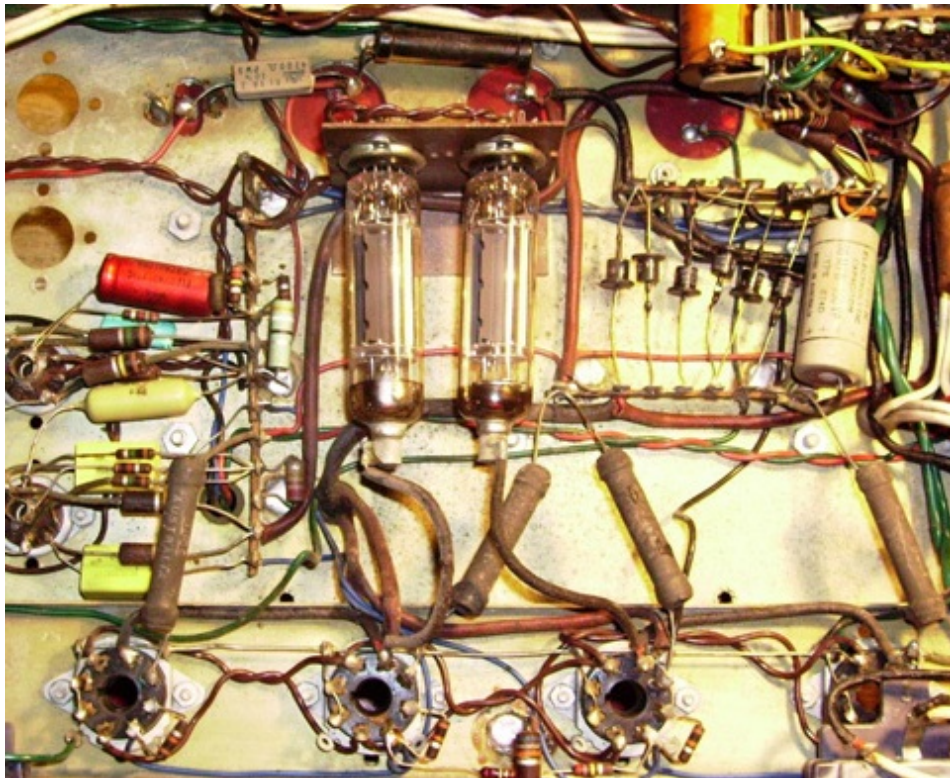
Figure 7. 6AL3 damper valves used as 'catch diodes' in a PP amp – and located underneath the chassis!

A more common technique was a 'catch diode' placed from plate to ground, also known as a suppressor, flyback or free-wheeling diode. For older amps this meant using valve diodes, such as the two 6AL3 TV damper diodes shown in Figure 7 under the chassis in a circa 1960 Australian Sound and Television 100W A-series PA amp. Modern ss diodes are more robust, and this technique is by far the most commonly used in guitar amplifiers, for example Ampeg used two 1.4kV diodes in series from 1971, from 1980 Fender's use an R3000 diode (3kV 0.25A), Peavey use a SR2873, and Bugera use an R2000.

A disadvantage of the catch diode technique is that only one half-primary winding section is directly protected, with the other half-winding left locally unprotected. The half-winding with a voltage spike going below 0V relative to OT CT (sitting at B+ voltage level) causes a spike current to loop through the protection diode and the power supply main filter capacitor back to the OT CT as the main energy dissipation means.

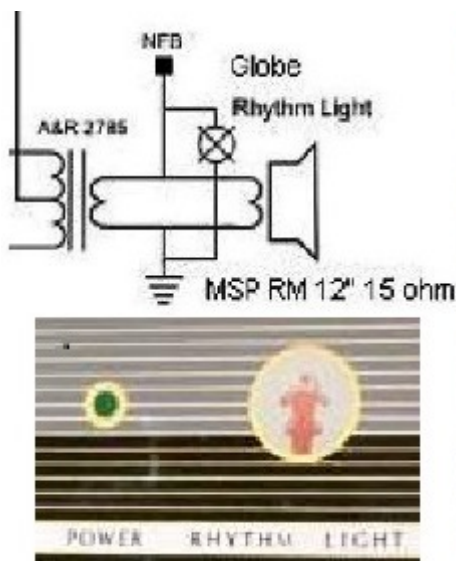
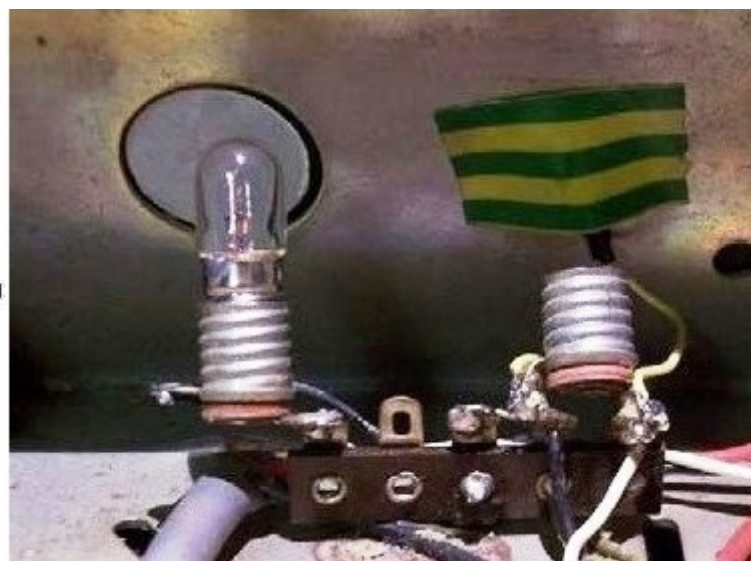
Figure 8. Goldentone made their OT secondary loading resistor into the RYTHM LIGHT 'feature' on the front panel, which provides about 10% loading, and a touch of non-linear compression due to resistance change.

Another common technique is to place a loading resistor on the OT secondary winding. The added resistance needs to be high enough to not need a large power rating, and not divert too much power away from the speaker. This simple technique provides some suppression of any high voltage spike. Power loss is inversely proportional to resistance, so an 820Ω resistor loading a nominal 8Ω speaker impedance would dissipate about 1% of the amp's power rating (ie. a 2W resistor should be fine for most amps). If the speaker was disconnected, and a voltage spike across the loading resistor reached say 3x the peak level normally seen, then the loading resistor would transiently dissipate 10% of the amp's power rating. Apart from wasting part of the signal power, and slightly modifying the load impedance seen at the OT secondary, this technique is somewhat soft in nature in that it doesn't force a voltage limit, and choosing a resistance for the loading resistor is a subjective compromise, not an empirical science.

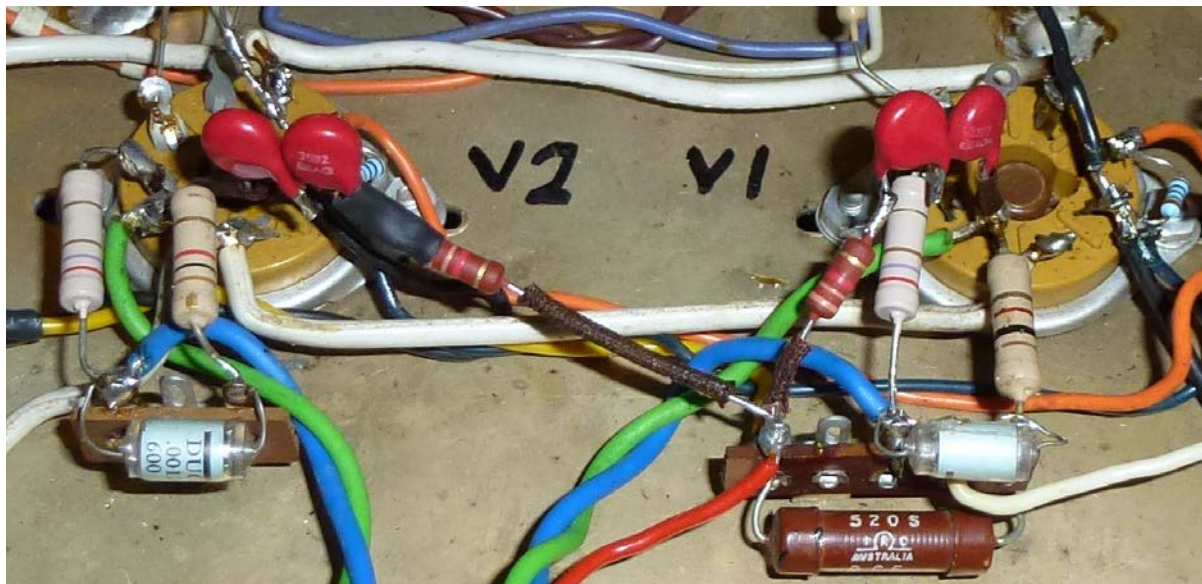
Figure 9. Ultra-linear PP stage (RTV&H 1960 100W PA amp). Original RC network from plate to screen. 1Ω cathode sense resistors added. Series MOV-R circuit added to each primary half. No screen stoppers added.

For an amp with 500VDC B+, then two or three of the V250LA4 MOVs in series, connected across each OT half-primary winding would be appropriate. Two MOVs would start to load any transient voltage peak rising above 708V to 946V, and if the energy level in the transient was sufficient to force the winding voltage to about 1200Vpk then the MOVs shunt load the winding with $600 + 600 = 1k\Omega$, passing about 1A. Three MOVs in series are also likely to clamp half-winding voltage to below 2kV, so may be the preferred arrangement. If a fault transient was a single pulse of width less than about 8ms, and current up to 1A, then the MOV experiences no degradation. If a repetitive transient was experienced, then MOV max average power level would determine if MOV degradation could occur.

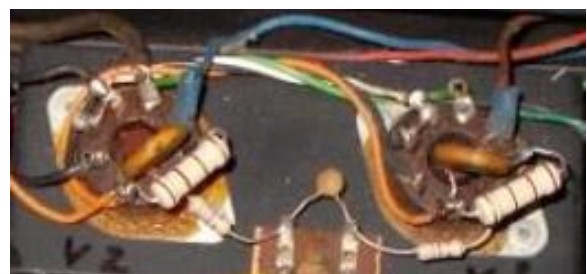
The OT windings connect to other parts that can also be stressed – in particular the output stage valve sockets have been known to arc between pins 2 and 3 (anode to heater) for typical power valves. Keeping the valve base surface clean between pins 2 and 3 is recommended, and some manufacturers glued spaghetti over those terminals and the OT wires.

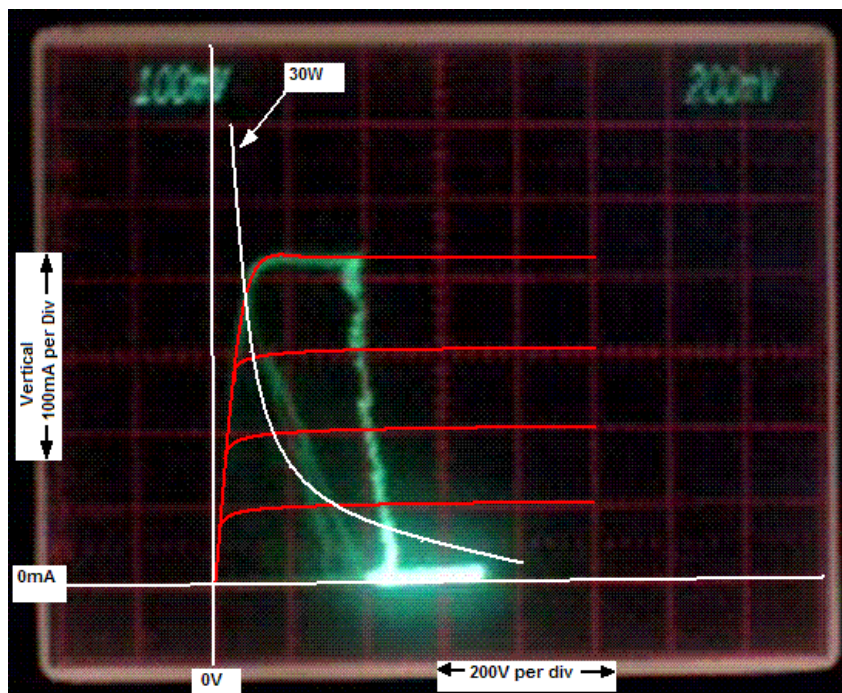
Oscilloscope measurements shown below on a Fender 5F6A re-issue using 6L6 tubes (thanks to Loudthud on [Music Electronics forum](#) for permission to use his measurements and further discussions on them) clearly indicate the voltage levels experienced at the anode in a fixed-bias PP circuit. The first oscilloscope plot shows a trace for 6L6 plate voltage and cathode current for a sedate guitar input signal (display of the voltage trace is helped by the persistence of the oscilloscope screen). The plot shows superimposed 6L6 datasheet anode current versus grid voltage curves, along with a 30W plate dissipation curve.

Returning to the above scope plot, a faint resistive loadline ($320V/350mA=0.9k\Omega$, or $1.8k\Omega$ PP) can be seen extending from the idle point to the red overlay at about 350mA and 80V. That locus then follows the red plate saturation curve to a higher current ($\sim 420mA$) at a higher voltage ($\sim 400V$), when the locus falls to the idle point along effectively a low resistance loadline. This loadline profile appears to represent a low frequency signal with sufficient drive for the plate voltage to saturate, and also sufficient duration for OT primary winding inductance to fall (core saturation) with plate current maintained by the plate I-V curve at constant $V_g=0V$, as winding voltage falls up until when the drive signal turns off that plate current.

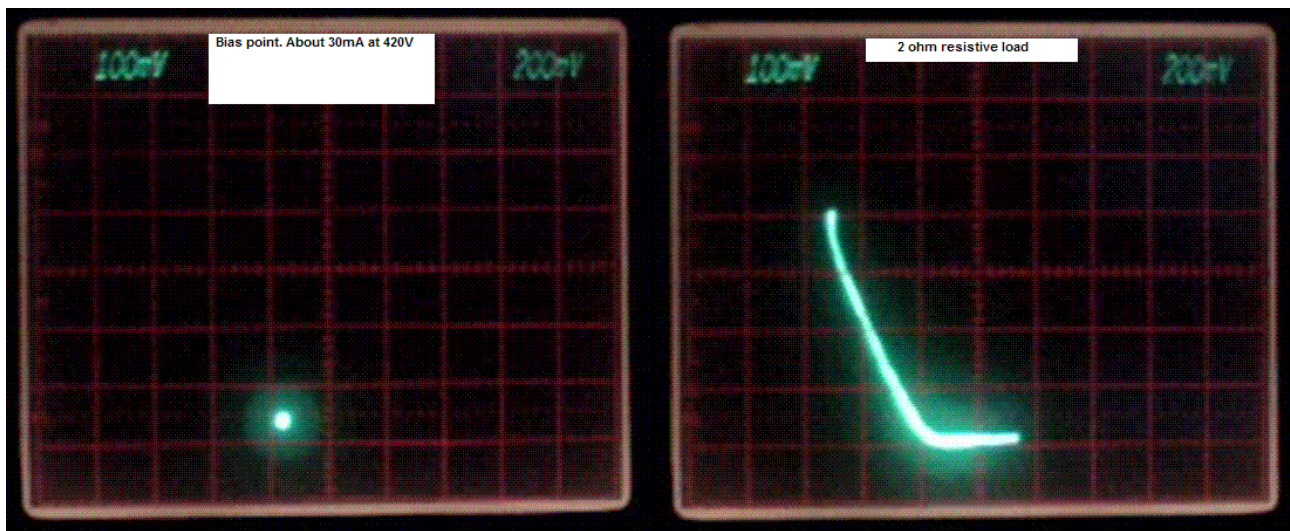
For a reference, the next plot below shows the 6L6 idle operating point at about 420V and 30mA. The 5F6A amp has a choke-fed screen voltage close to the idle anode voltage. The third plot shows the load line being followed when a sinewave signal is applied to a resistive load – the operating point moves away from the idle point, to a lowest anode voltage of about 80V and highest cathode current of about 400mA when being driven in to conduction by the signal, and to a highest anode voltage of about 720V at near zero cathode current when being driven in to cut-off. In this plot the anode voltage moves symmetrically below and above the B+ level (which would sag from 420V to about 400V) and indicates no sign of voltage stress on the OT winding. The peak anode current (and hence OT primary current) would be somewhat less than the measured 400mA cathode current, as the screen current contribution is seen to increase the trace's gradient noticeably as grid conduction conditions are approached.

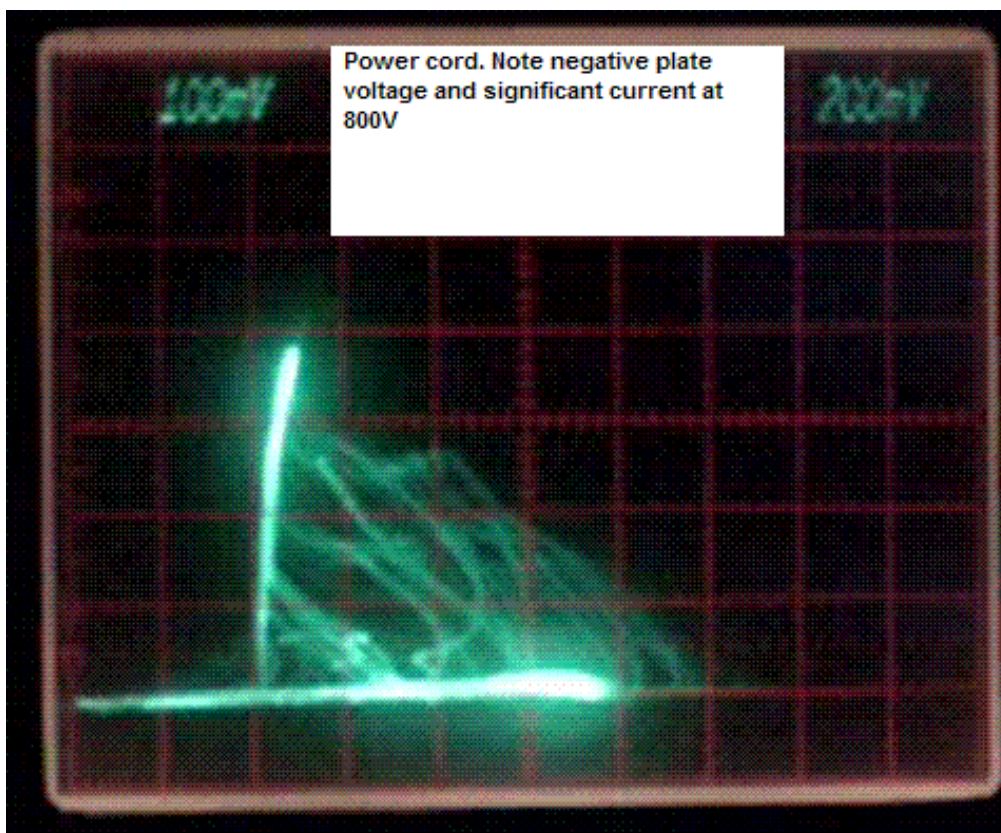
The 6L6 experiences more dramatic voltage excursions as shown below when a speaker load is used with a more aggressive guitar playing style, but still a long way from extreme over-drive conditions. The plot shows plate voltage extending down to at least -800V, and up to +1100V, which is about -1200V and +700V relative to B+ on the CT of the output transformer.

The 5F6A is likely to be experiencing blocking distortion under high signal level, which causes crossover distortion that would force both valves into cut-off at the same time for a portion of time. The plot below indicates a square-wave type plate operation, with an unloaded horizontal plate voltage falling from idle, followed by plate current rising along the $V_{g1}=0V$ vertical curve to a high plate current period, followed by V_{g1} falling and plate current and voltage falling back to idle or cut-off conditions via many different paths (likely due to remnant energy in primary winding leakage inductance or speaker cone movement).

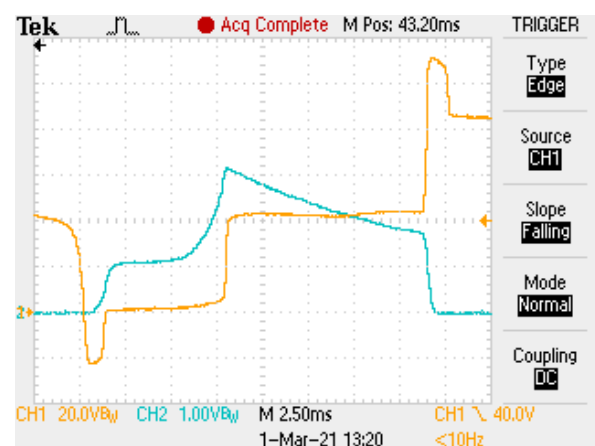
The time expanded plot above shows the clipped voltage waveform in more detail for when both positive and negative transients are constrained by the one MOV across the half-primary winding. The voltage rise during MOV conduction in the plot is about 50V, which for the CNR 10D681K MOV used indicates a peak MOV current of about 2-3mA (ie. a minimum dynamic damping resistance of about 200kΩ) for about 1ms, and an average power dissipation of nearly $750V \times 3mA \times 1ms / 16.6ms = 0.13W$ (ie. <0.4W for indefinite life).

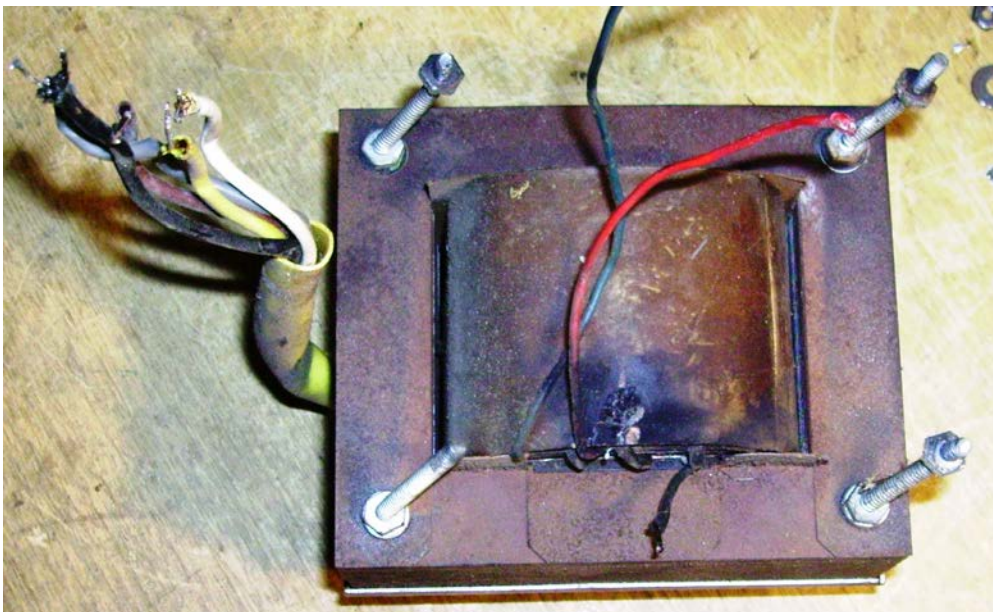
Figure 10. A dropped amplifier caused this OT to bend its mounting bolts and short a primary plate wire to chassis – no internal wiring damage, so it's back in the amp and working now.

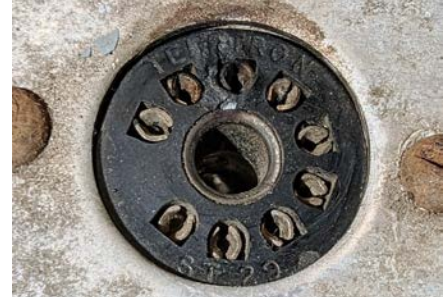
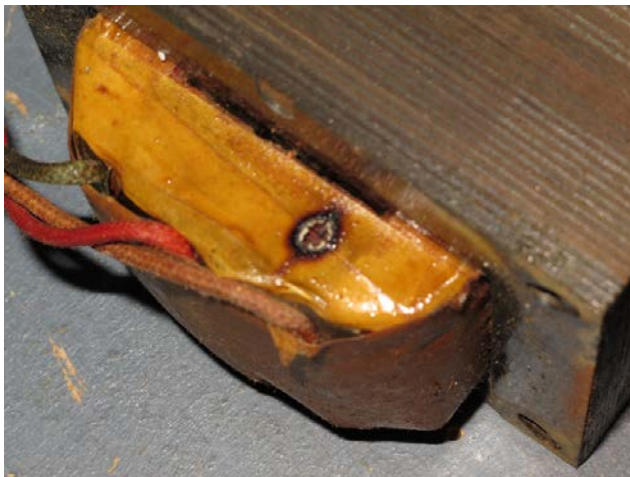
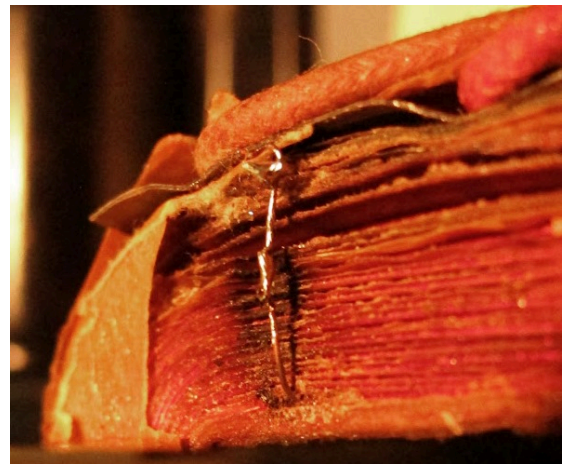
The charred pin 7 socket terminal for a 6BW6 anode (novel 6V6) highlights a need for careful inspection to show up arcing.

Figure 11. Repairable fault in output transformer.

Figure 11 shows a repairable fault in an OT. Arcing from half-primary winding layer edge turns to the other half-winding plate link wire had caused an obvious area of over-heating damage that resulted in an open-circuit. The OT was repaired by replacing the link wire, and carefully insulating it (not shown). [[Hoffman Amplifiers Forum](#) but thread now lost]. Figure 12 shows a lucky primary winding repair – with broken turns in outer layer on the edge – made somewhat difficult due to beeswax potting.

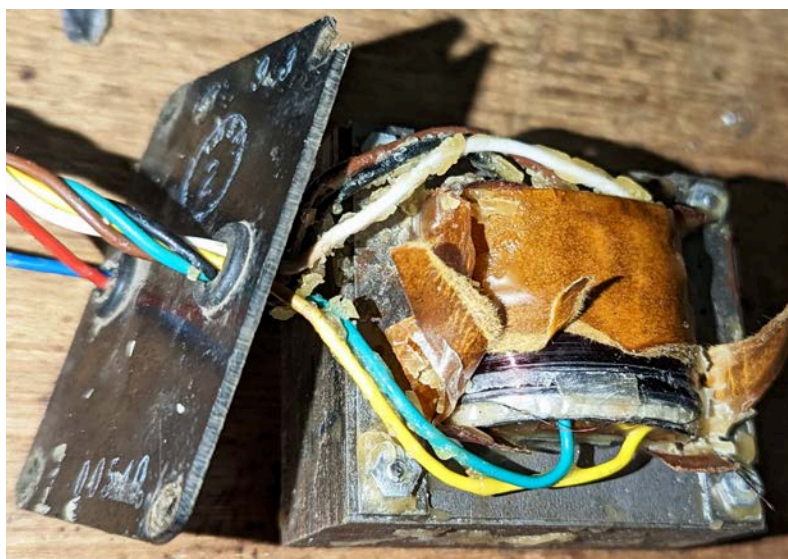
Figure 12. Broken turns repaired in outer primary winding of 3W SE A&R OT933.
